Field Study of the Effect of Ice on Sediment Transport and Shoreline Erosion - St. Marys
River, St. Clair River, Detroit River, Michigan: Volume IV

FIELD STUDY OF THE EFFECT OF ICE
ON
SEDIMENT TRANSPORT AND SHORELINE EROSION
ST. MARYS RIVER, ST. CLAIR RIVER, DETROIT RIVER
MICHIGAN

SUBMITTED BY: GEORGE R. ALGER, PHD
WATER RESOURCES CONSULTANT

SEPTEMBER 1979

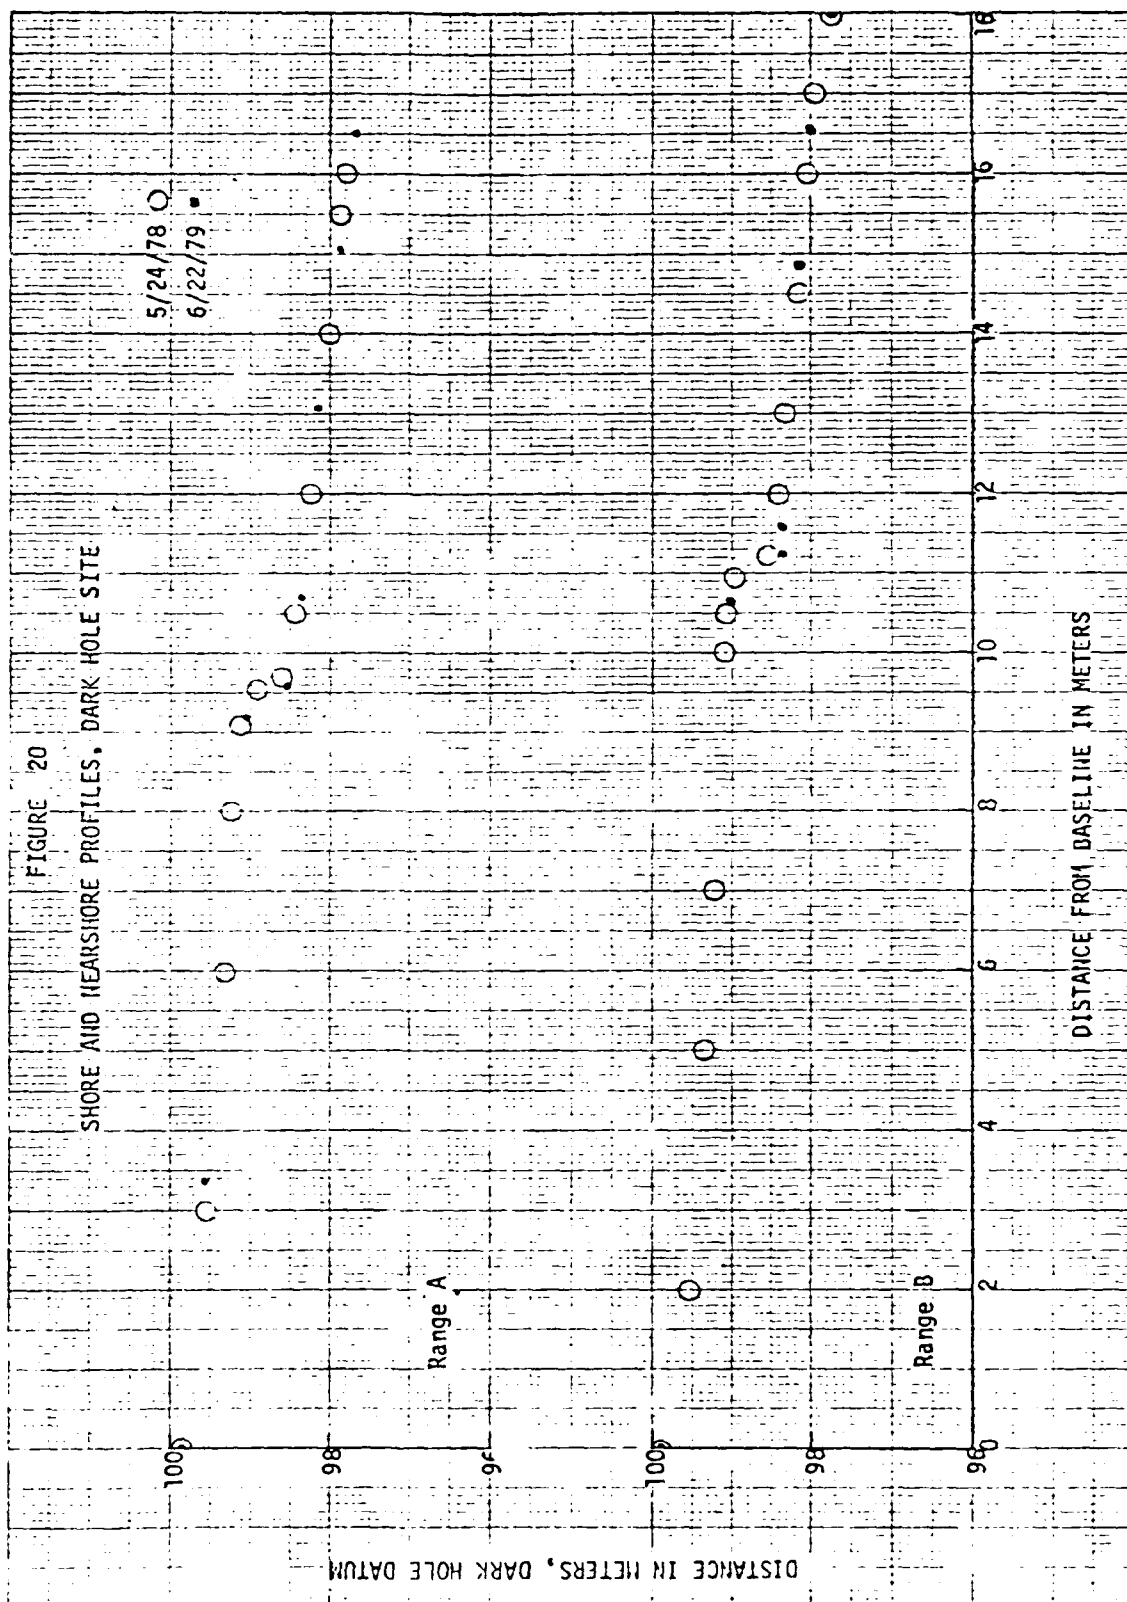
Shore profiles were measured along the two ranges which had been previously established by CRREL. The results of these measurements are illustrated on Figure 20. Figure 20 also shows the results of similar measurements made by CRREL on May 24, 1978. There does not appear to be any material movement of the scarp along these two ranges over the period between measurements (over one year). The water level was 0.18 meters higher on 6/22/79 than on 5/24/78 which could account for the small differences shown at the base of the scarp.

Two soil samples were collected along range A-A', one near the shoreline and one at the drop off shown on Figure 20 at 9 meters from A'. An analysis of these samples is shown below.

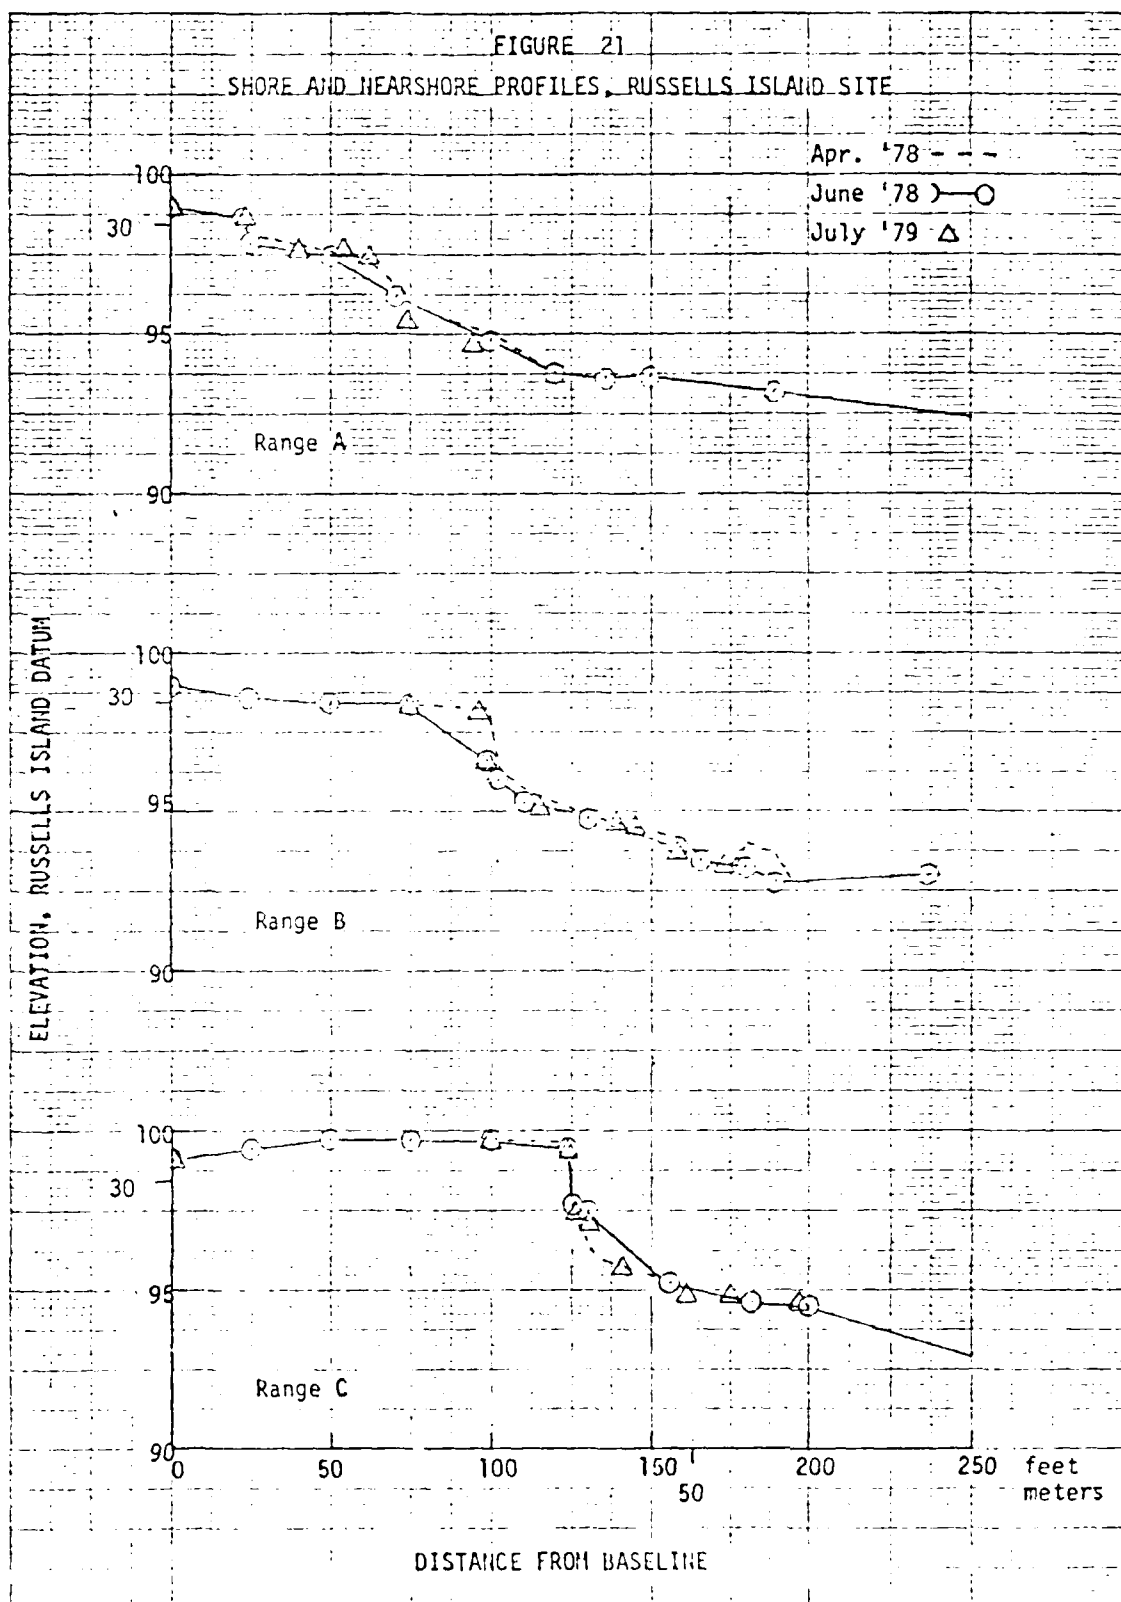
FIGURE 21
SHORE AND NEARSHORE PROFILES, RUSSELLS ISLAND SITE

A field study was initiated on July 12, 1979 at the Russells Island Site. Details of site location and range line position may be found in Volume 3 of a previous report furnished to CRREL, November 1978. (A Study of Ice Related Sediment Transport and Shoreline Erosion). Figure 21 shows the historic shoreline changes measured during 1978 and 1979. Table 5 shows alterations in scarp position. Noticable recession is evident in the lower portion of the reach. Offshore profiling was also done by boat using a survey fathometer for all ranges. No measurable changes were noted in the offshore bottom profiles.
